Hill County Traffic Safety Improvements Study

prepared by Robert Peccia & Associates
Helena, Montana
September, 1989

Hill County, Montana

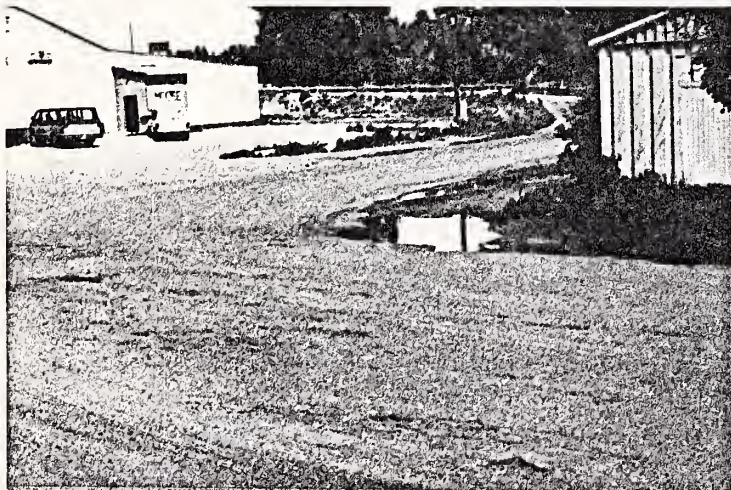
Photograph 3

Photograph 3: Surface runoff tends to pond on the inside of the curve. The pavement in the intersection is in poor condition with numerous potholes. Centerline striping has been completely worn off by vehicles crossing over it to avoid bad spots in the road.

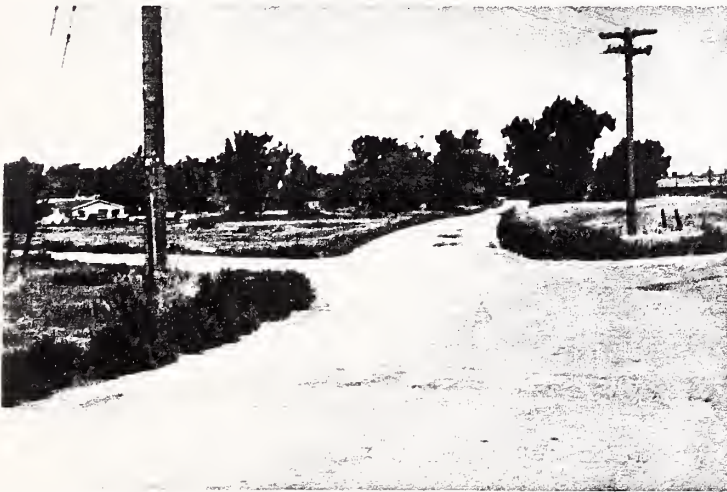
Photograph 1

Photograph 1: This photo shows the awkward intersection geometrics as viewed from the west approach on First Street North.

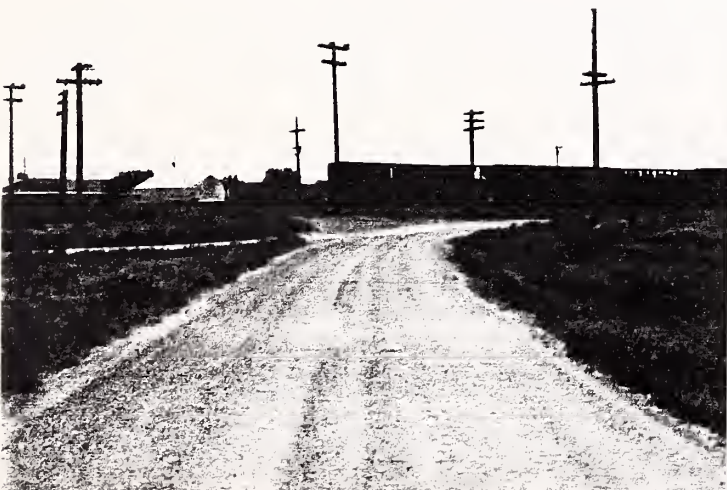
Photograph 3

Photograph 3: Thirteenth Avenue is an 18-foot-wide paved road and intersects First Street from the north. The Burlington Northern tracks border the intersection to the south.

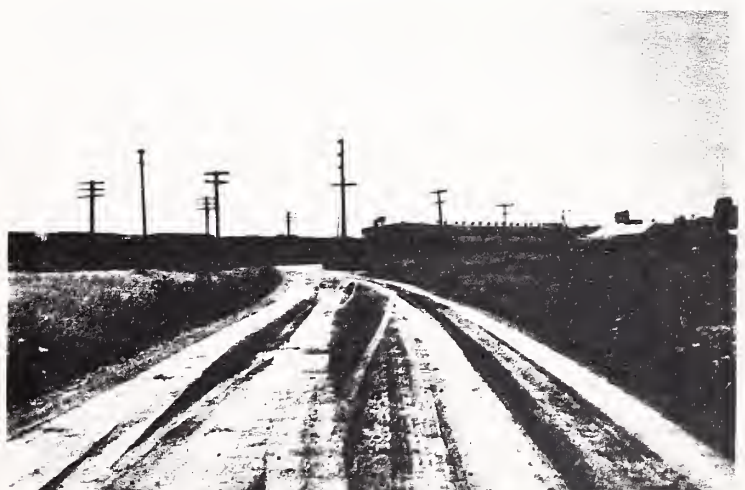
Photograph 4

Photograph 4: The east approach to the intersection has a 23-foot-wide gravel surface. There are no sight distance problems at this site since the adjacent land is flat and free of structures and tall vegetation.

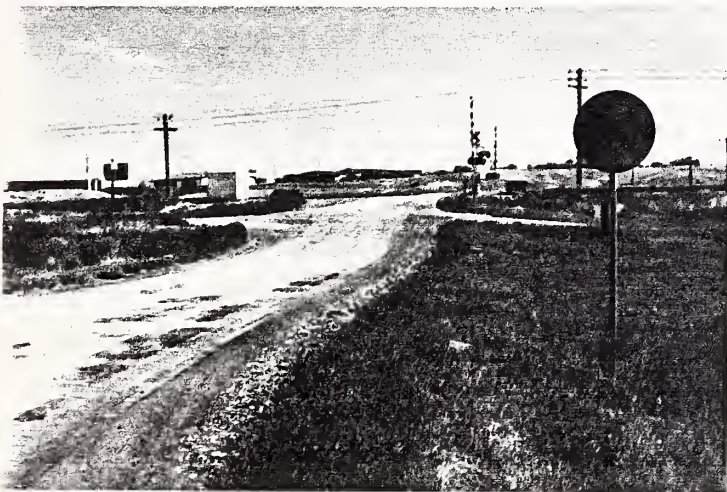
Photograph 1

Photograph 1: This railroad crossing sign on the northwest approach was the only sign found standing at this site. The posts for railroad crossing signs on the northeast and south approaches were found, but the signs were missing.

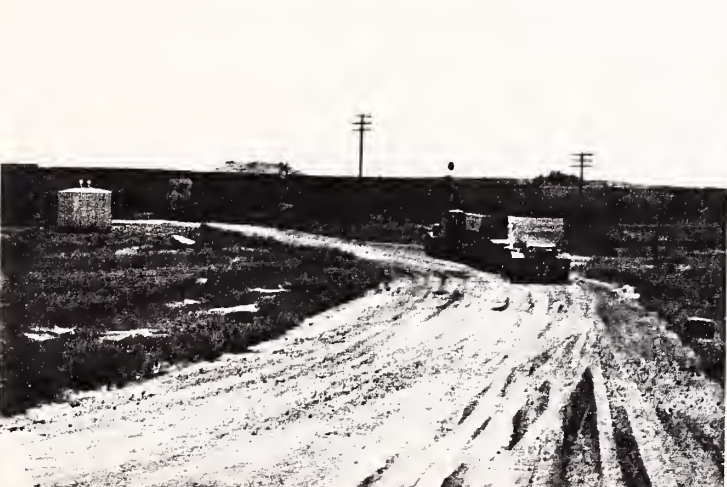
Photograph 3

Photograph 3: Numerous large trucks use this crossing when traveling to and from the gravel pit located northeast of the site. The crossing warning lights and gate were functioning correctly at the time of the site visit.

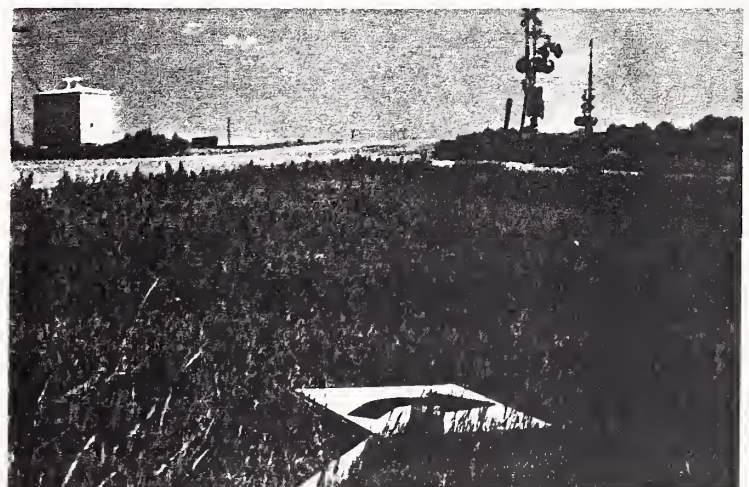
Photograph 4

Photograph 4: This curve warning sign was lying in the grass on the side of the north-east approach to the crossing.

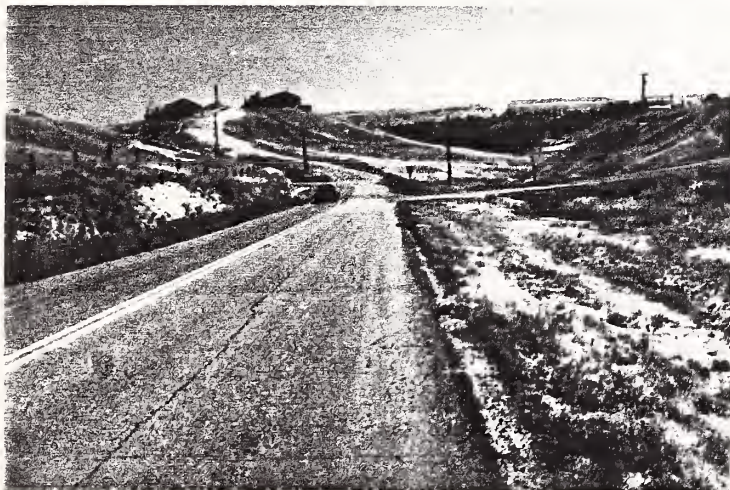
Photograph 1

Photograph 1: The driver's view of this intersection is unobstructed from the west approach on County Road 651. Boulevard Avenue comes down the steep hill on the right and is controlled with a yield sign.

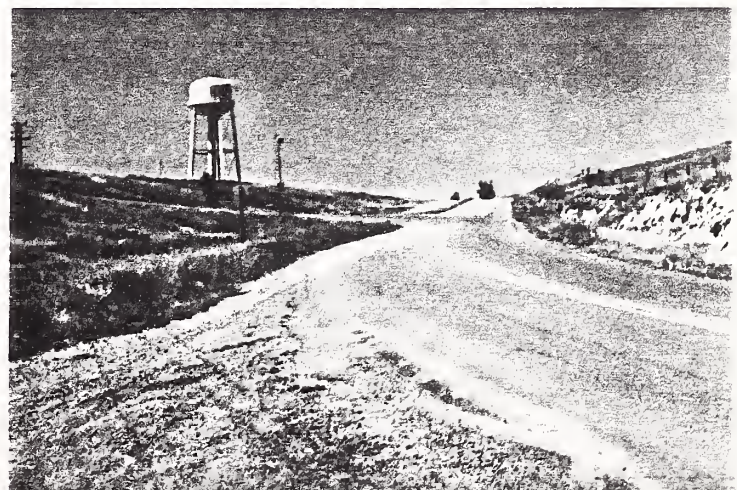
Photograph 2

Photograph 2: Motorists approaching the intersection from the east have this view of the site. Over 80% of the vehicles that approach from the east turn left onto Boulevard Avenue.

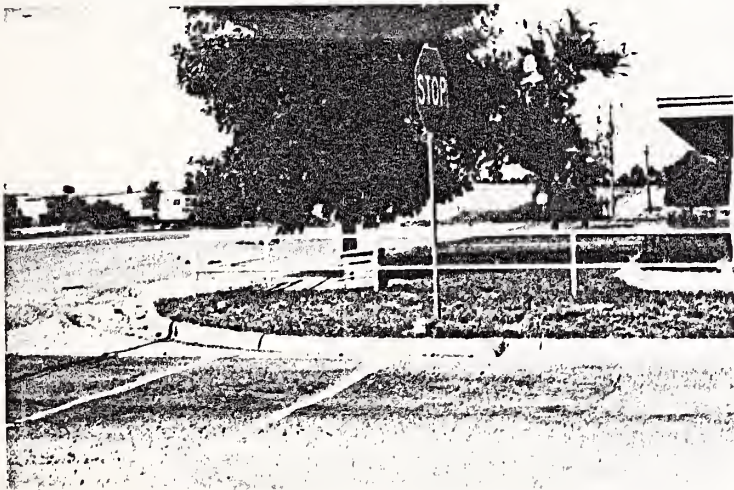
Photograph 1

Photograph 1: The large tree located on the northeast corner of the intersection blocks the driver's view of the traffic approaching from the west on Eleventh Street. The stop sign is located 40 feet from the edge of Eleventh Street.

There is a major sight-distance problem at this site. A vehicle at the stop sign on Sixteenth Avenue cannot see the traffic approaching the intersection from the west. This is caused by several problems. The stop sign is located 40' from the north edge of Eleventh Street. Sight-distance obstructions located on the northwest corner of the intersection include trees, a steel rail fence, tall grass and shrubs, and parked vehicles. There is also a significant grade change 100' west of the intersection. The road changes from flat to a 6% grade sloping to the west.

- Long-Term Improvement:** The sight-distance problems at this intersection are caused by the roadway grades on Eleventh Street west of the junction. This portion of Eleventh Street should be reconstructed with a longer vertical curve and flatter grades. The crest of the hill should be cut down by 3' or 4'.

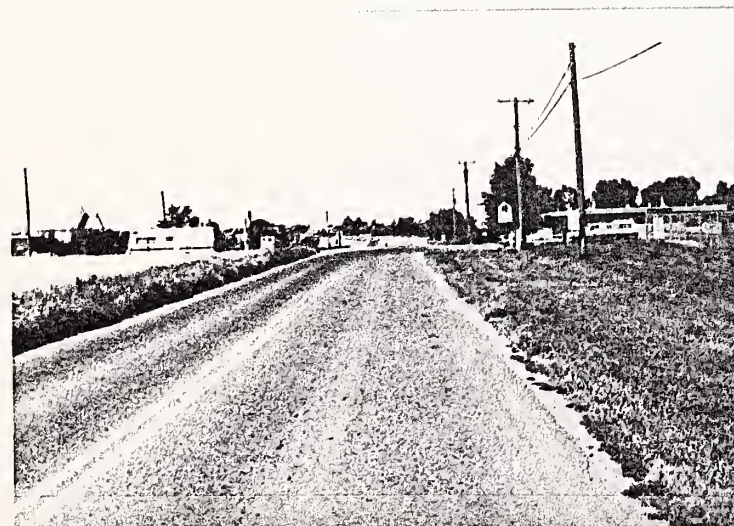
Photograph 3

Photograph 3: The east approach to the intersection is flat with relatively few visual obstructions adjacent to the roadway.

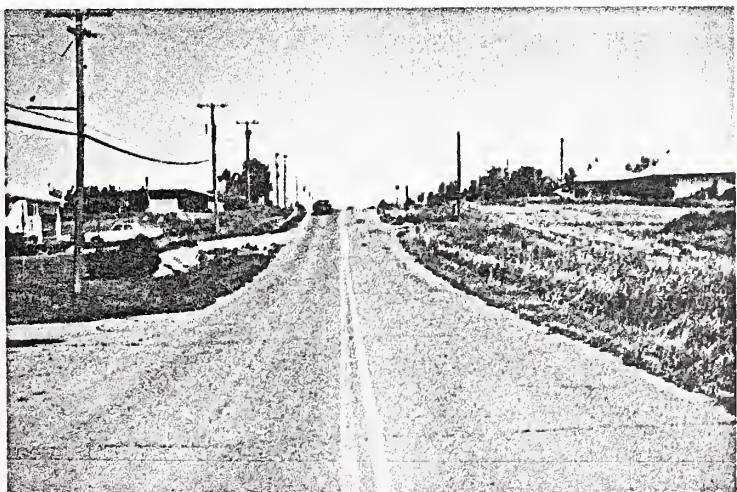
Photograph 4

Photograph 4: The intersection cannot be seen from the west approach due to the sharp change in the grade of the roadway. The intersection is 100 feet east of the top of the grade shown in this photo.

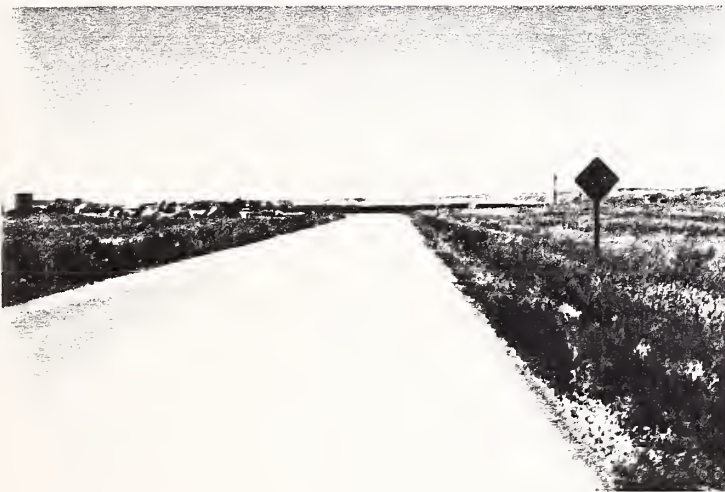
Photograph 1

Photograph 1: This reverse curve sign is located on the east approach to the site. The roadway is marked with a yellow double solid centerline throughout the site.

<u>List of Improvements</u>	<u>Estimated Cost</u>
• Remove the existing reverse curve warning sign located east of the site.	\$ 50.00
• Install curve warning signs (W1-2, 30"x30") along with 35 mph advisory speed plates (W1-13, 18"x18") on both approaches to this curve. Place these signs 400' from the beginning of the curve as shown in Figure 7B.	360.00

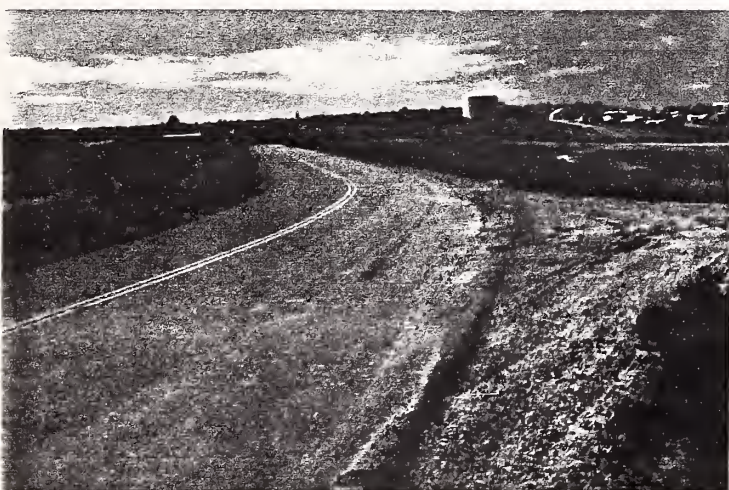
Photograph 3

Photograph 3: A gravel driveway is located on the outside of the curve. This photo shows the west approach to the curve. Southeast Havre can be seen in the distance..

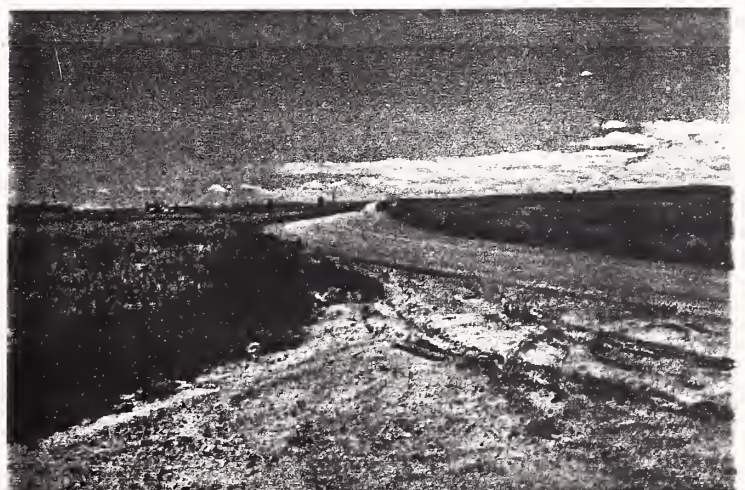
Photograph 4

Photograph 4: This picture of the east approach was taken while standing in the gravel driveway to the gas line building. The east approach is straight and slopes toward the intersection at a grade of 1.5%.

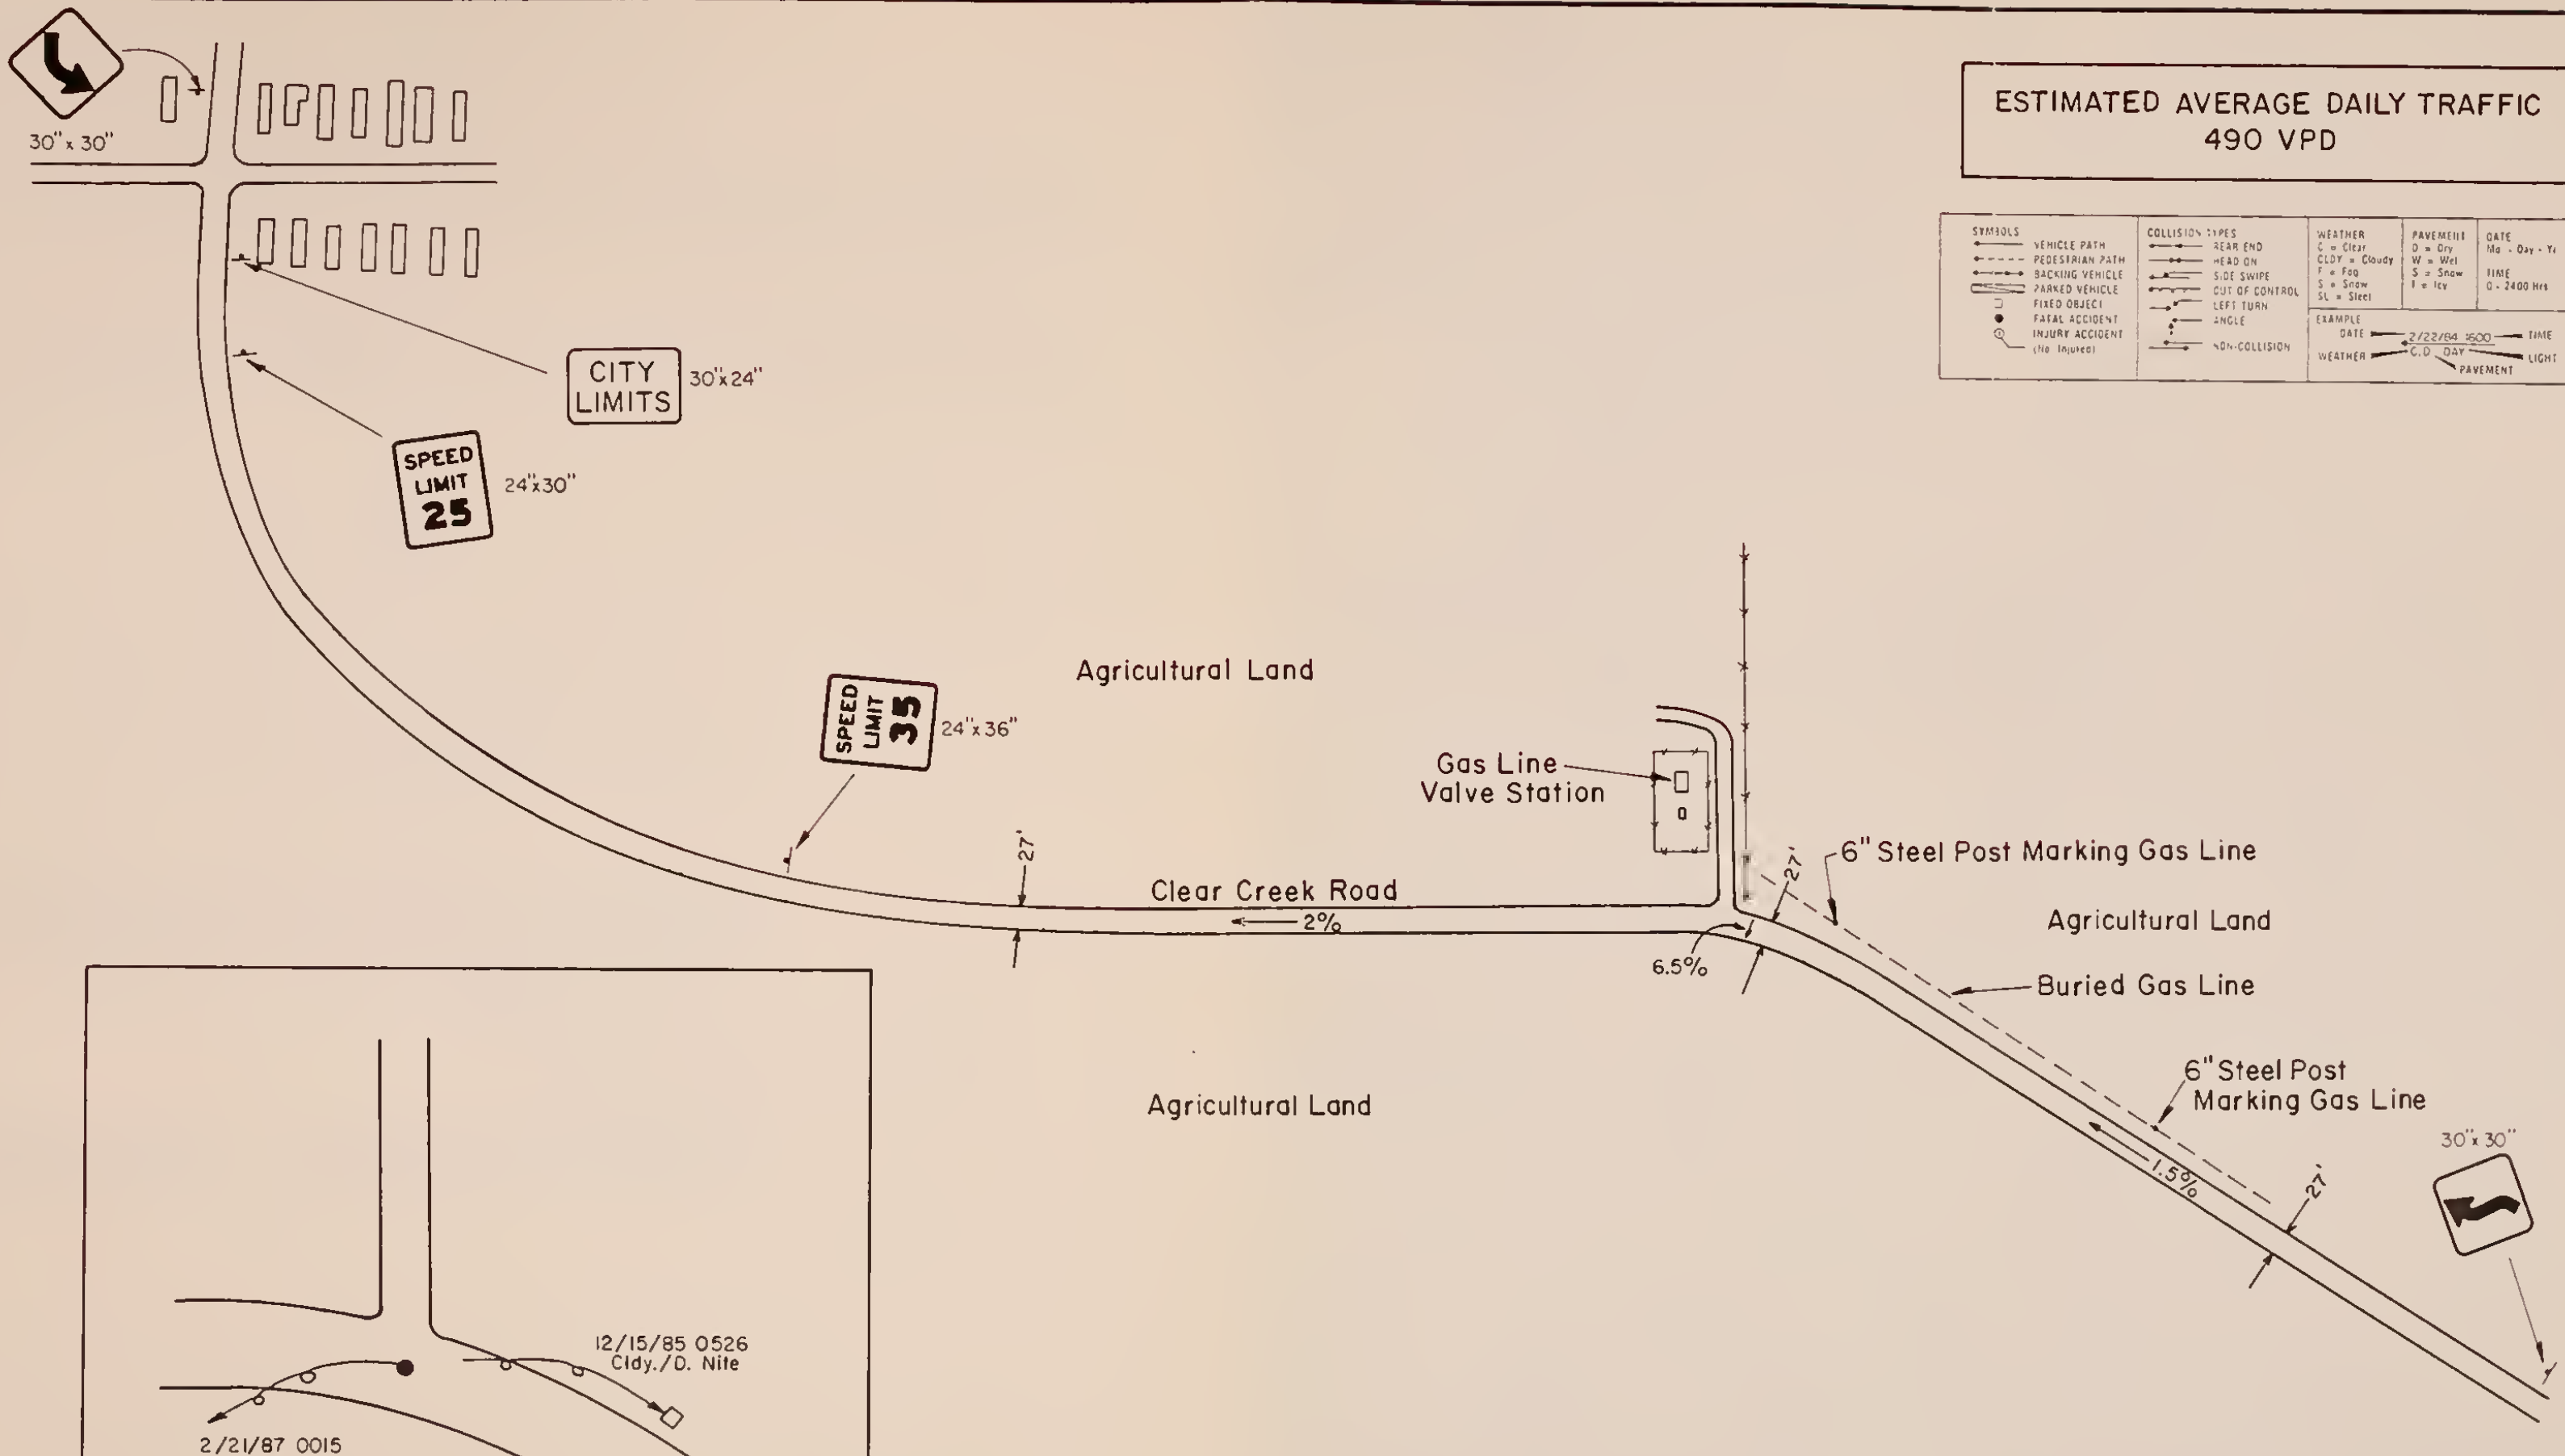
Site 7
Existing Conditions &
Collision Diagram
Figure 7A

The curve on Clear Creek Road was the site of two single-vehicle accidents during the four-year study period. In both cases, the vehicle left the roadway in the curve while traveling at a high rate of speed. Both accidents occurred at night when it was clear and dry. One accident involved an eastbound vehicle that slid off the north side of the roadway and rolled over, hitting a gas pipeline sign in the process. No one was incurred as a result of the incident. The other accident occurred when a westbound motorist lost control of his vehicle in the curve and left the roadway. The vehicle crossed the ditch on the south side of the road and entered the adjacent field. The vehicle rolled over twice throwing the driver and passenger into the field. The driver was killed and the passenger severely injured. Alcohol was involved in this accident. Refer to the data below and the collision diagram on Figure 7A for additional details of the accident history at this site.

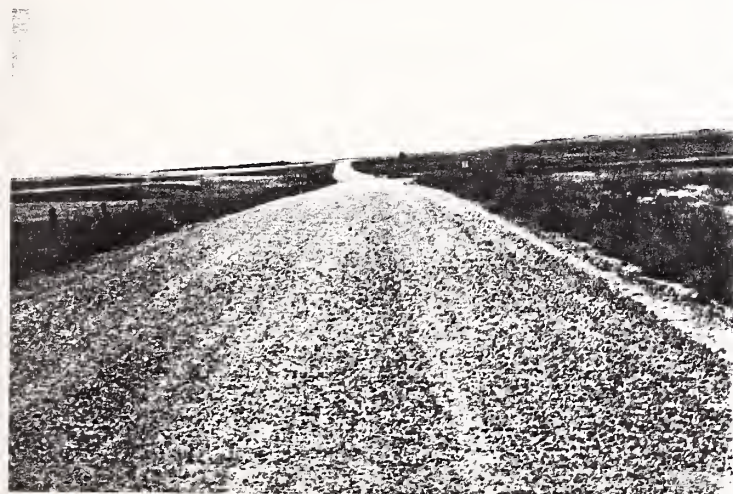
Photograph 1

Photograph 1: The west approach to the intersection on the Clear Creek Road is 28 feet wide and gravel surfaced. The road surface was in good condition at the time of the site evaluation.

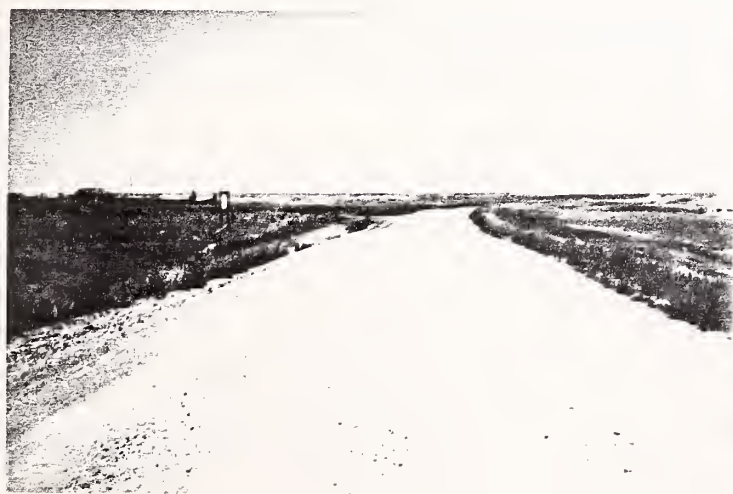
Photograph 3

Photograph 3: The intersection is difficult to see on the approach from the east. Clear Creek Road east of the intersection carries approximately 70 vehicles per day.

Although Clear Creek Road is relatively flat and free of sight-distance obstructions, the location of the intersection is difficult to identify on both the east and west approaches, especially at night. The recommended short-term improvements for this site are to install advance warning signs on all three approaches to the intersection.

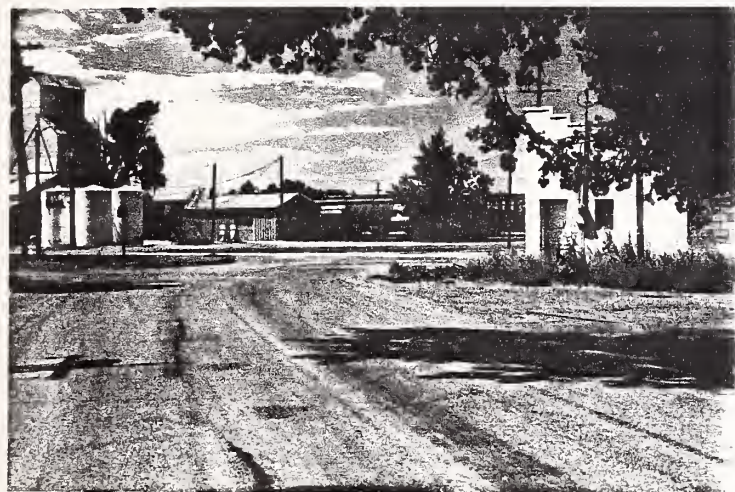
Photograph 1

Photograph 1: The west end of Main Street curves to the right on the approach to the junction with U.S. Highway 87. The driver's view of the stop sign is blocked by the white building on the right.

Two other deficiencies were identified at this site. Since the stop sign at the U.S. Highway 87 intersection is not visible to approaching traffic, a "Stop Ahead" warning sign should be posted. The other deficiency is the lack of pavement markings on Main Street. A center-line that restricts passing maneuvers and edgeline striping will provide the motorist with additional guidance, especially at night.

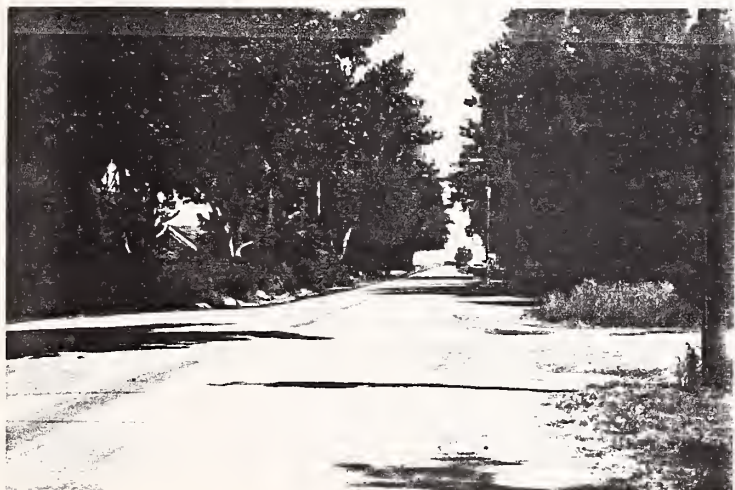
Photograph 3

Photograph 3: This photo shows a view of Main Street looking east from the junction with Third Street. A property owner on the north side of the street has placed large rocks within the right-of-way to protect his fence from errant vehicles.

One safety problem was identified on the north side of Main Street. A resident has placed large rocks in the County right-of-way to protect his fence from vehicle impacts. The rocks constitute a more serious hazard to motorists than the fence and represent a liability to the County since they are on County property. The rocks were involved in at least one fixed-object accident during the study period.

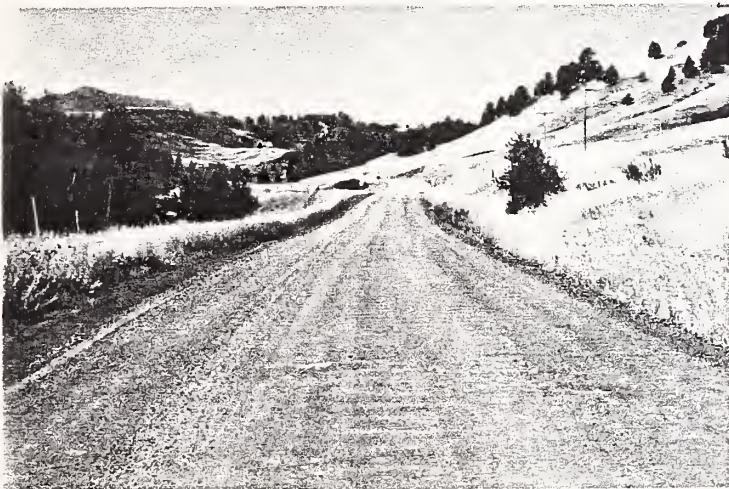
Photograph 1

Photograph 1: This photo shows Taylor Road looking west at the reservation boundary. The road changes from pavement (on the reservation) to a dirt/gravel surface at the cat-tleguard at the west end of the site.

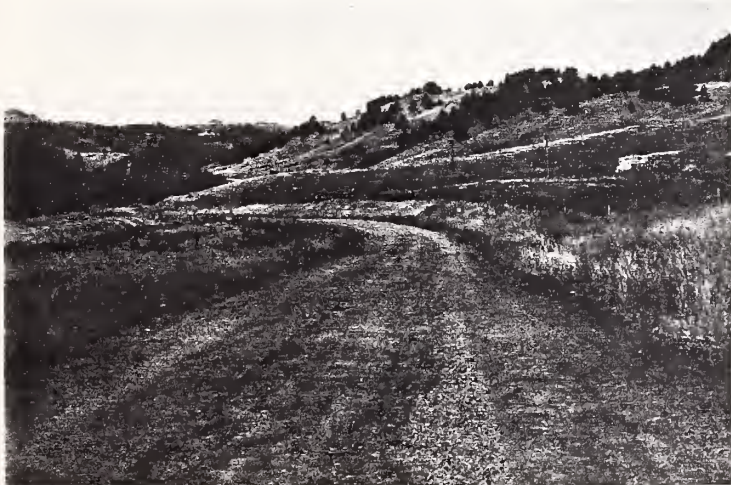
Photograph 3

Photograph 3: There are several broad curves in the road throughout the site. None of the curves are signed or delineated in any way.

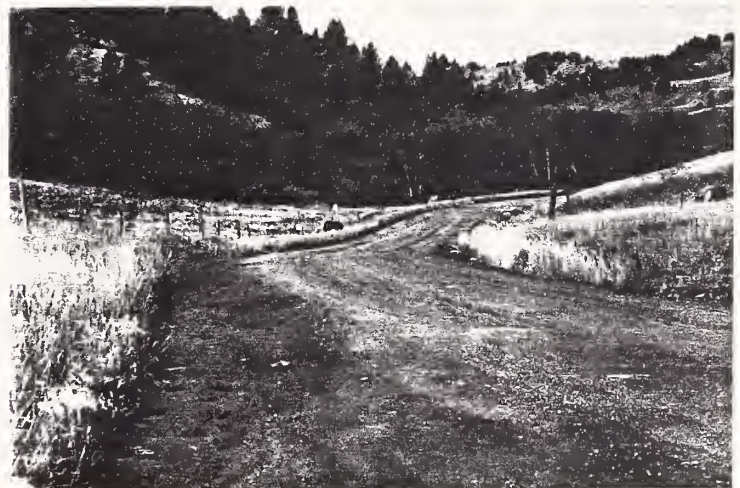
Photograph 4

Photograph 4: Taylor Road climbs a steep grade at the east end of the site. This photo looking east shows the curves at the beginning of the grade up the hill.

The accident history at the site indicates that advance warning of the curves would be beneficial. The winding road section that climbs the hill at the east end of the site is of particular concern. A vehicle equipped with a ball bank indicator was used to determine that 35 mph is the maximum safe speed for this set of curves. Warning signs should be used to identify this condition. Warning signs should also be used to identify the reverse curves located in the center of the site. The tangent road sections do not present identifiable hazards to motorists traversing the site. Sight distance is limited at the crest of the hill at the east end, but vehicle approach speeds are relatively low and the accident history does not indicate any problem at this particular location.
